Soil infested with Japanese knotweed

Wrapping with Dupont™ Plantex® Platinum

Location:

Amsterdam, NL

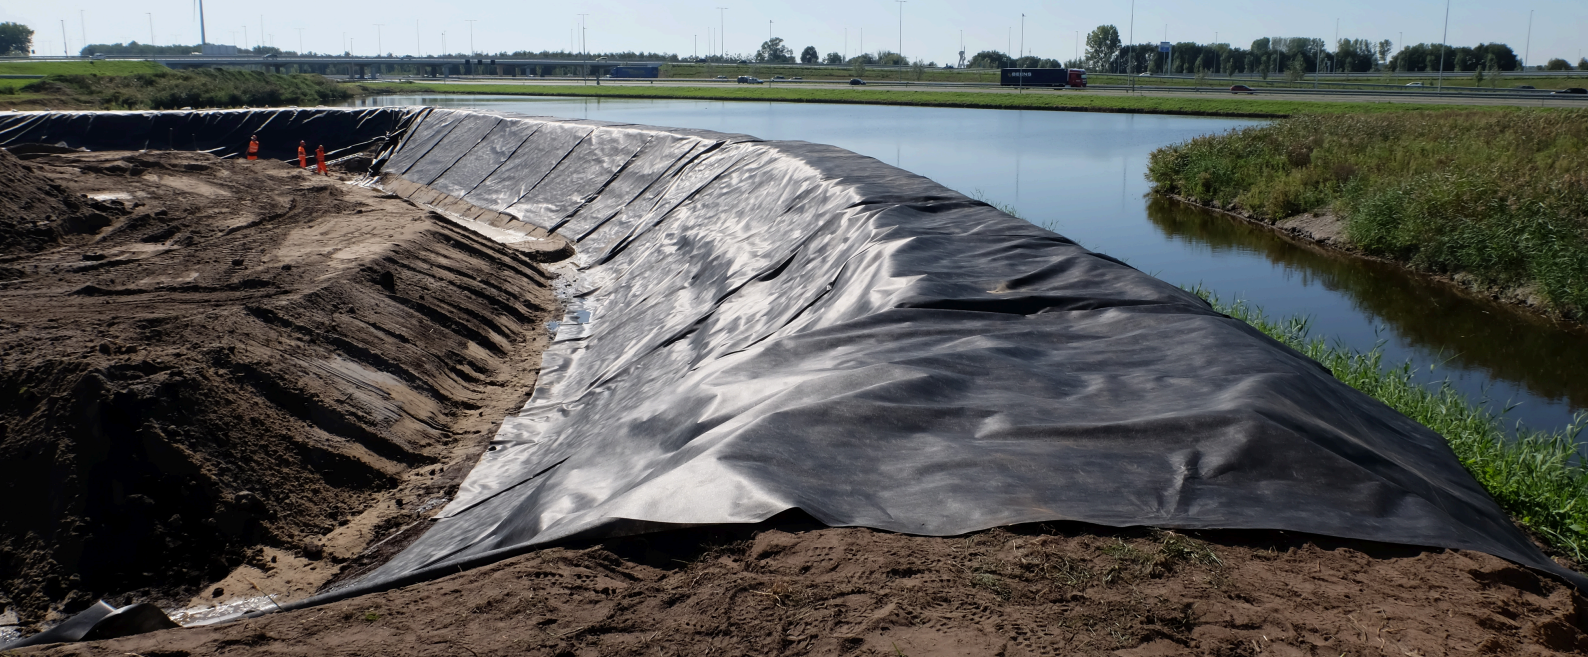
A Japanese knotweed depot wrapped in Plantex® Platinum.

The removal, transport and incineration of the contaminated soil entailed such high costs that an alternative solution was sought. A better alternative was found in Plantex® Platinum; this weed barrier has been specially developed to combat Japanese knotweed and is perfectly suited to creating a containment area and covering the Japanese knotweed-infested soil.

The project is divided into two phases; Phase 1 involves covering the slope around the depot, and in Phase 2 the depot is fully covered. After covering, a 25 cm layer of clean soil was applied, which was immediately sown with grass and flower seeds to encourage biodiversity.
